# Valley Crossing Over Time

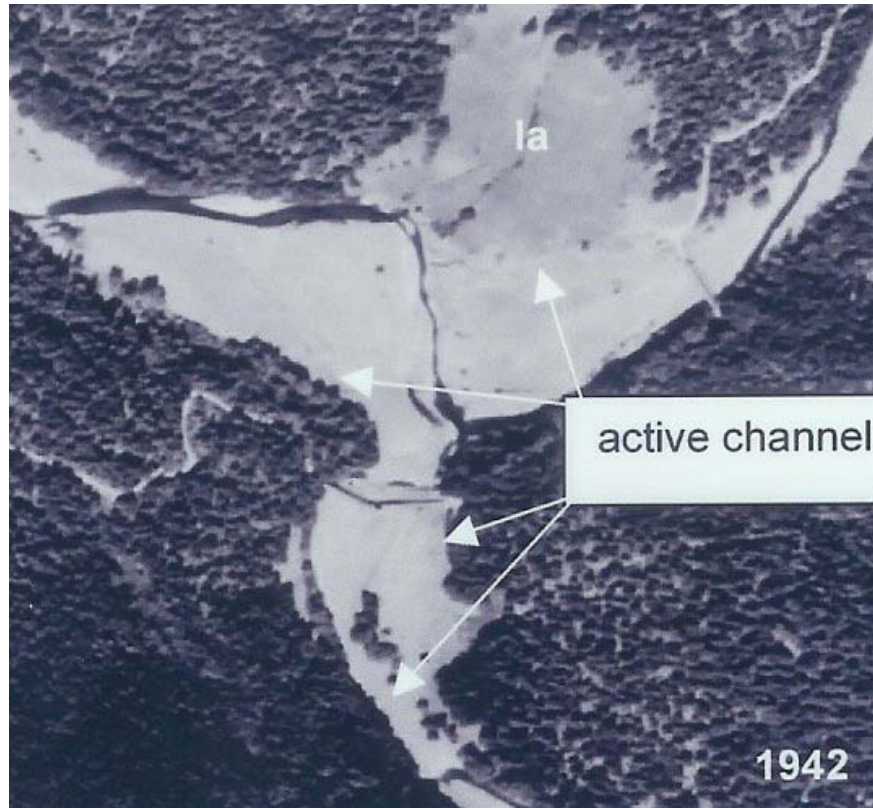
07/01/42 0 ' Up Wheatfield Dir 0 Cr Station 0 LWD Site 0  
12:00 PM Photo 4024 Road# 40 Mi. 1.6 Map Pt. 2450 THP Maintenance

This photo was in the Geology and Geomorphology section of the North Coast Watershed Assessment - Gualala (Klamt - 2003). The annotation was by Michael Fuller, CEG. "Upper photo shows channel in 1942 meandering north into toe of landslide."

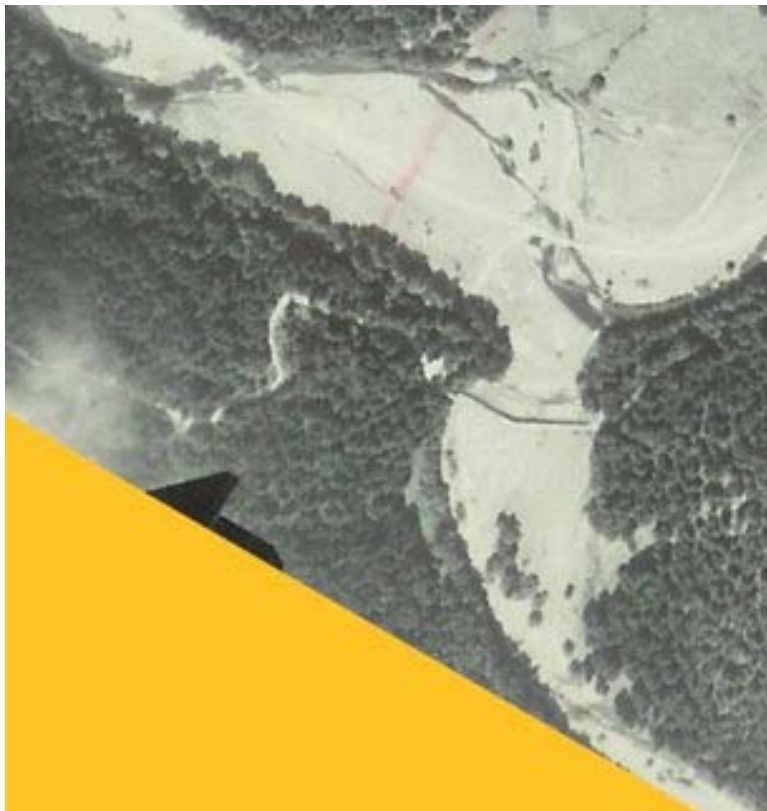
09/22/52 0 ' Up Wheatfield Dir 0 Cr Station 0 LWD Site 0  
12:00 PM Photo 4012 Road# 40 Mi. 1.6 Map Pt. 2450 THP Maintenance  
The South Fork is dry but seems to cross over to the right bank where the new bridge is now.

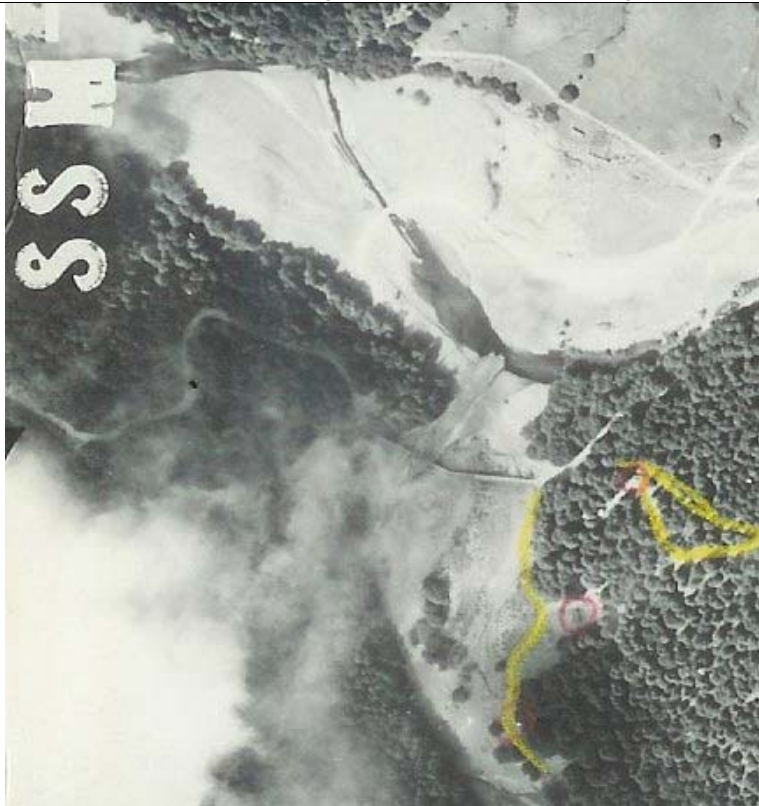
09/15/56 0 ' Up Wheatfield Dir 0 Cr Station 0 LWD Site 0  
12:00 PM Photo 4014 Road# 40 Mi. 1.6 Map Pt. 2450 THP Maintenance  
The South Fork is in the center of the channel.

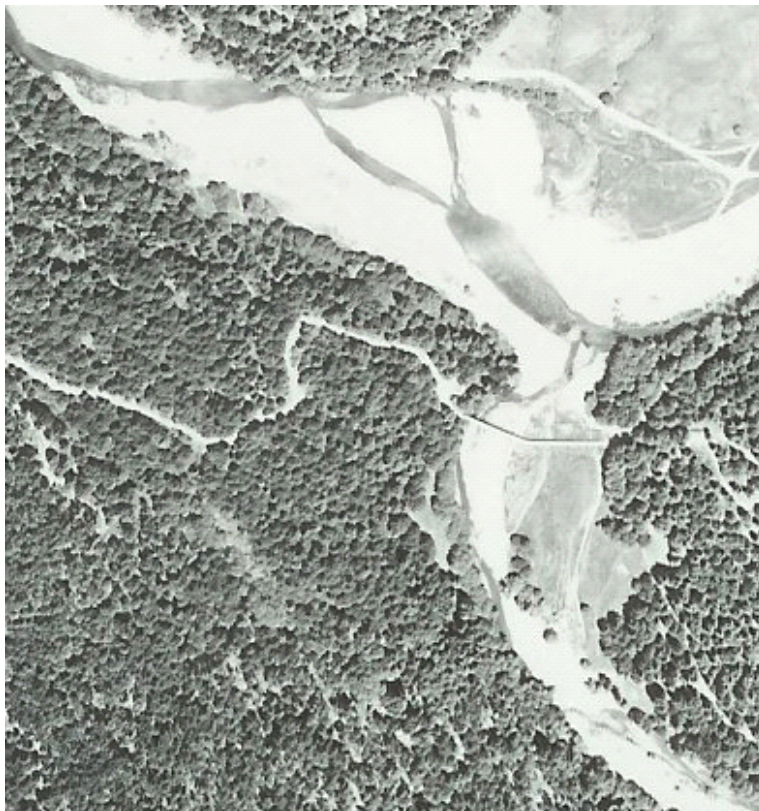
05/04/59 0 ' Up Wheatfield Dir 0 Cr Station 0 LWD Site 0  
12:00 PM Photo 4022 Road# 40 Mi. 1.6 Map Pt. 2450 THP Maintenance  
The South Fork is in the center of the channel.

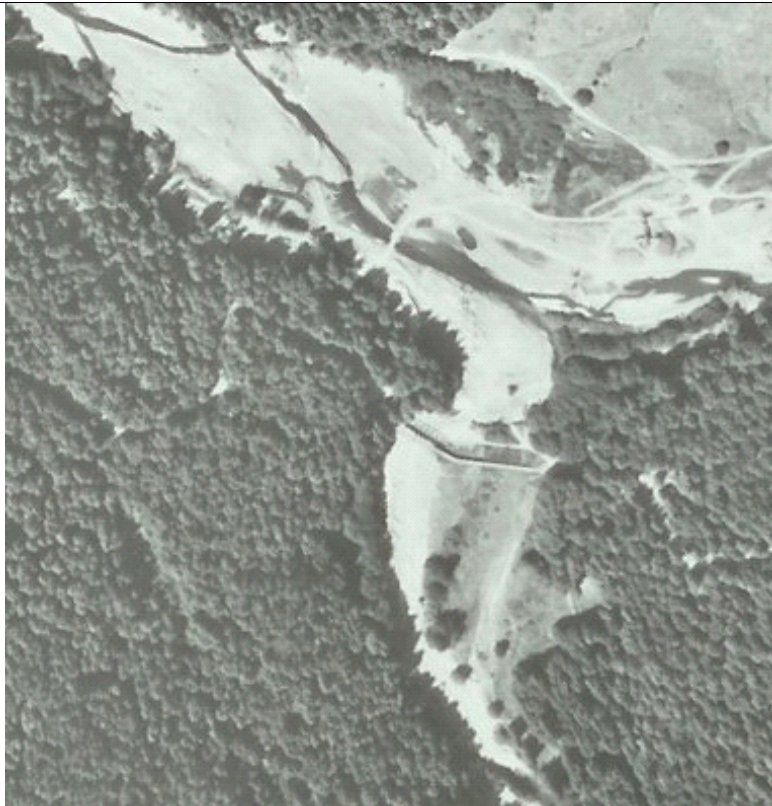
09/15/71 0 ' Up Wheatfield Dir 0 Cr Station 0 LWD Site 0  
12:00 PM Photo 4013 Road# 40 Mi. 1.6 Map Pt. 2450 THP Maintenance  
The South Fork seems to cross over to the right bank where the new bridge is now.

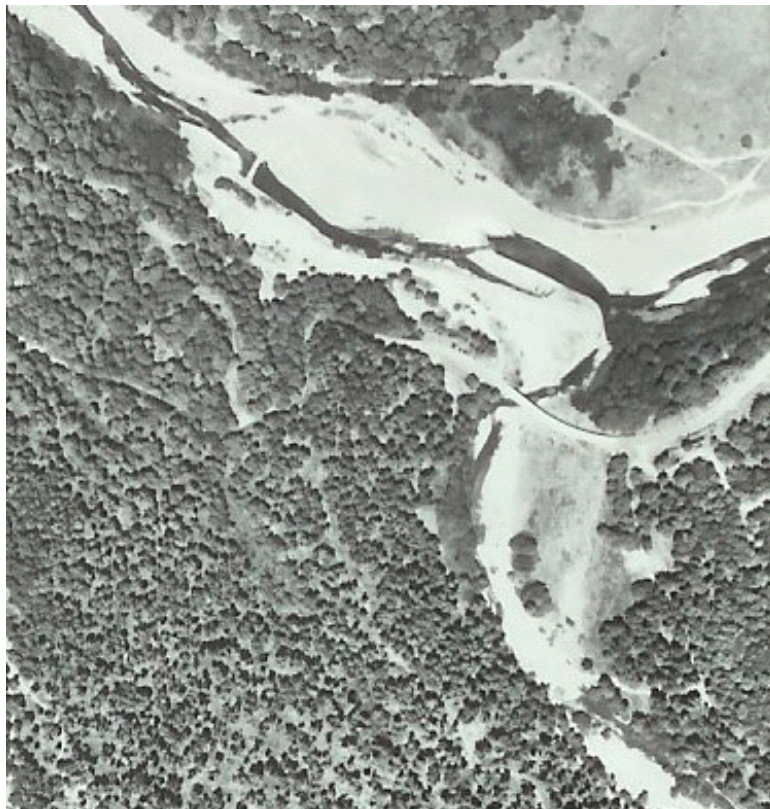
06/26/84      0 ' Up   Wheatfield      Dir 0      Cr Station 0      LWD Site      0  
12:00 PM   Photo 4019   Road# 40      Mi. 1.6      Map Pt. 2450   THP Maintenance  
The South Fork crosses over to the right bank under the new bridge.

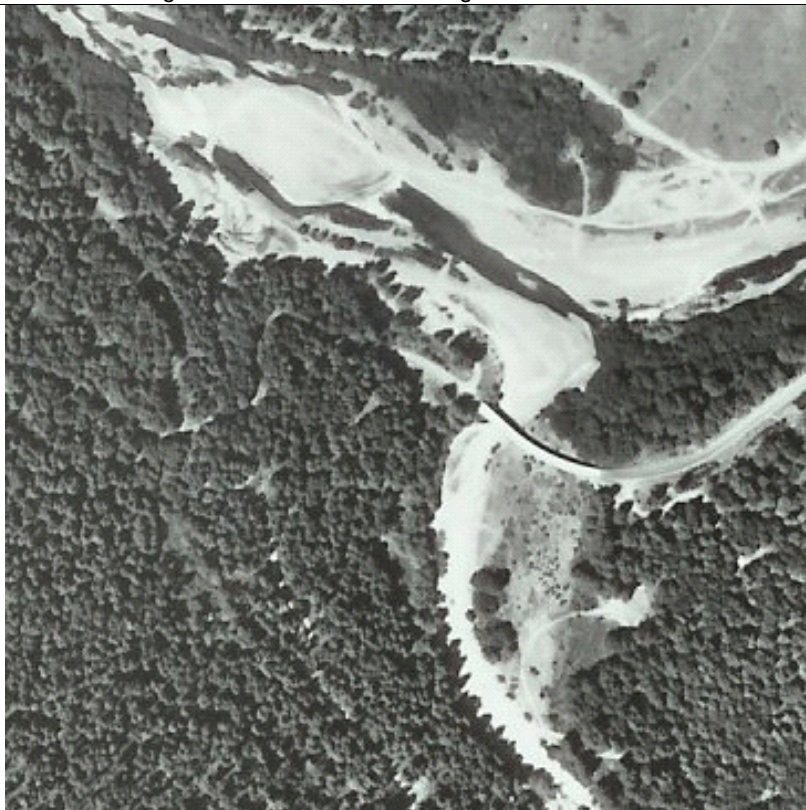
08/16/88      0 ' Up   Wheatfield      Dir 0      Cr Station 0      LWD Site      0  
12:00 PM   Photo 4015   Road# 40      Mi. 1.6      Map Pt. 2450   THP Maintenance  
The South Fork crosses over to the right bank under the new bridge. It seems dry.

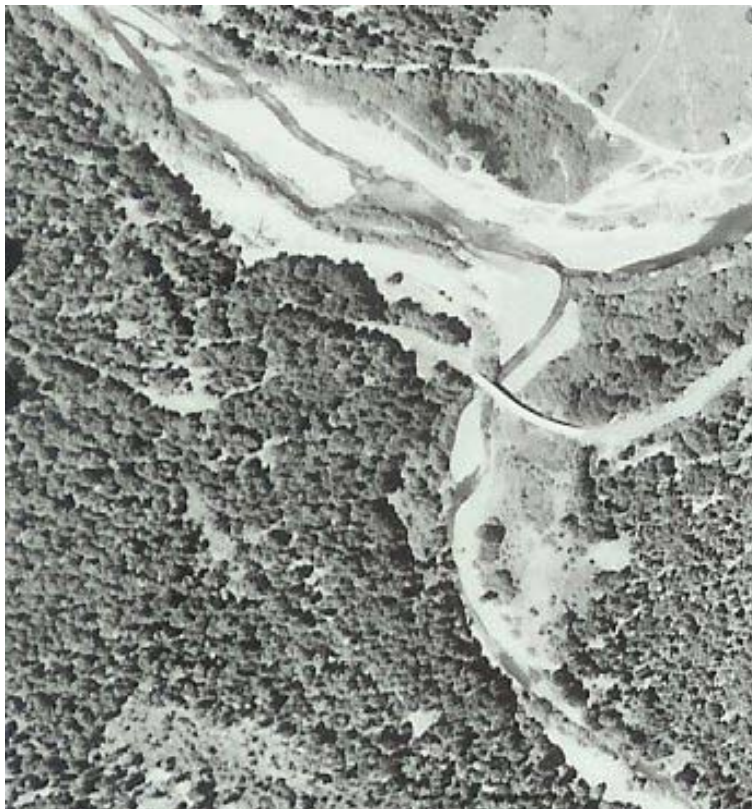
06/26/93 0 ' Up Wheatfield Dir 0 Cr Station 0 LWD Site 0  
12:00 PM Photo 4018 Road# 40 Mi. 1.6 Map Pt. 2450 THP Maintenance  
The South Fork is in the center of the channel.

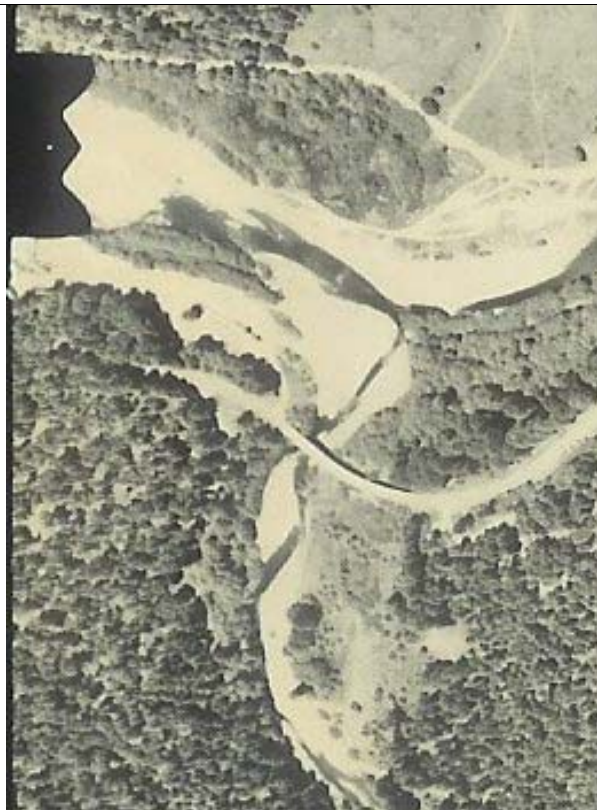
06/08/94 0 ' Up Wheatfield Dir 0 Cr Station 0 LWD Site 0  
12:00 PM Photo 4021 Road# 40 Mi. 1.6 Map Pt. 2450 THP Maintenance  
The South Fork is in the center of the channel.

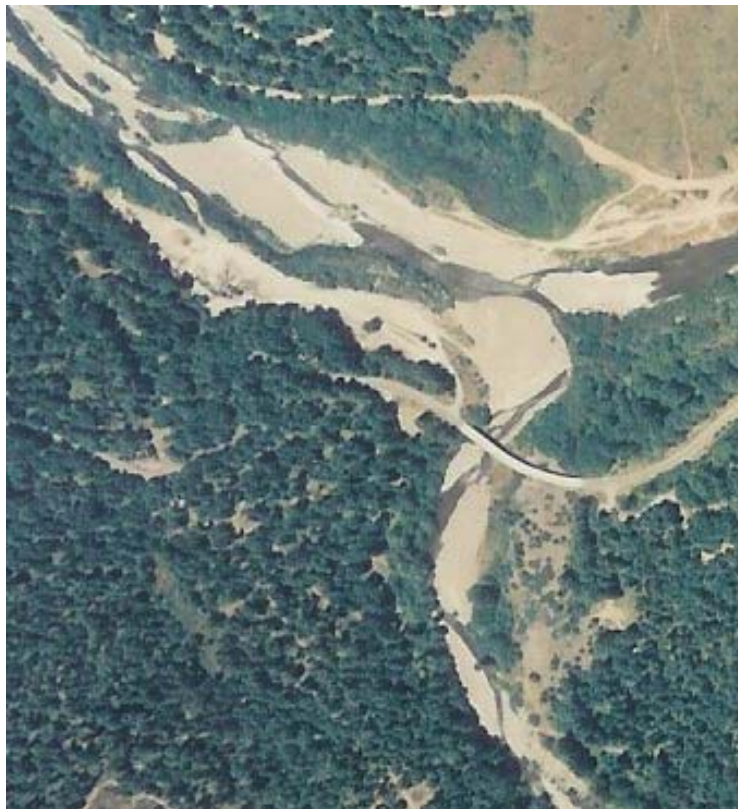
07/01/96 0 ' Up Wheatfield Dir 0 Cr Station 0 LWD Site 0  
12:00 PM Photo 4017 Road# 40 Mi. 1.6 Map Pt. 2450 THP Maintenance  
The South Fork is on the right side but not up against the bank.

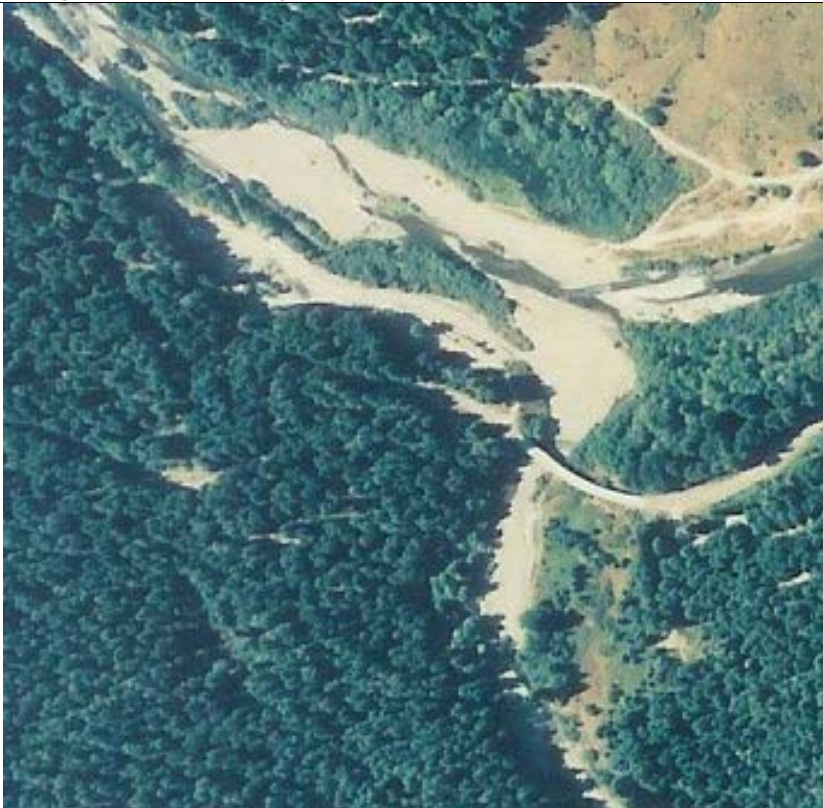
07/17/98 0 ' Up Wheatfield Dir 0 Cr Station 0 LWD Site 0  
12:00 PM Photo 4016 Road# 40 Mi. 1.6 Map Pt. 2450 THP Maintenance  
The South Fork is on the right bank.

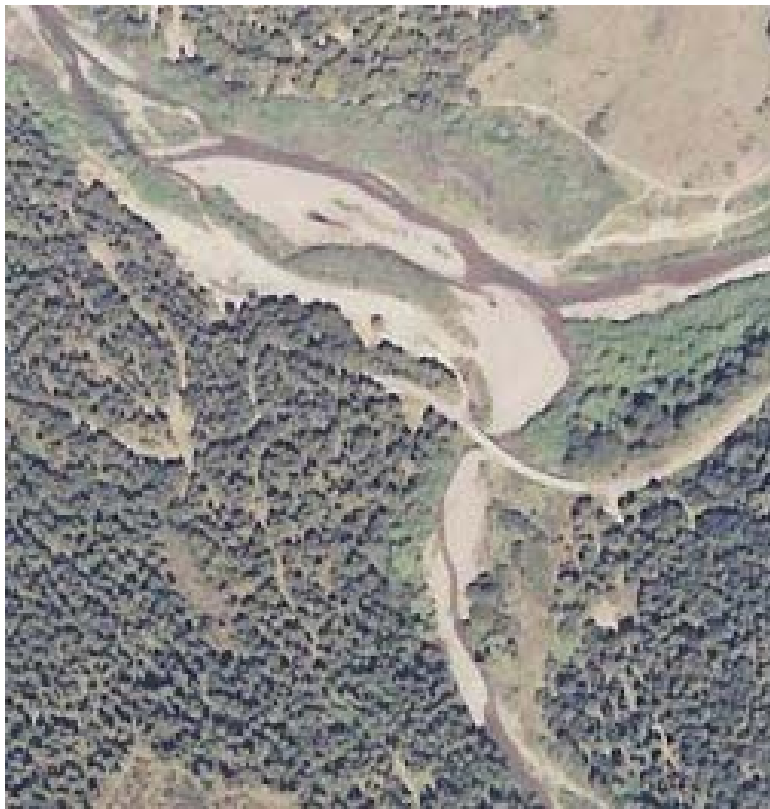
04/22/02      0 ' Up   Wheatfield      Dir 0      Cr Station 0      LWD Site      0  
12:00 PM   Photo 4023   Road# 40      Mi. 1.6      Map Pt. 2450   THP Maintenance  
The South Fork is on the right bank.

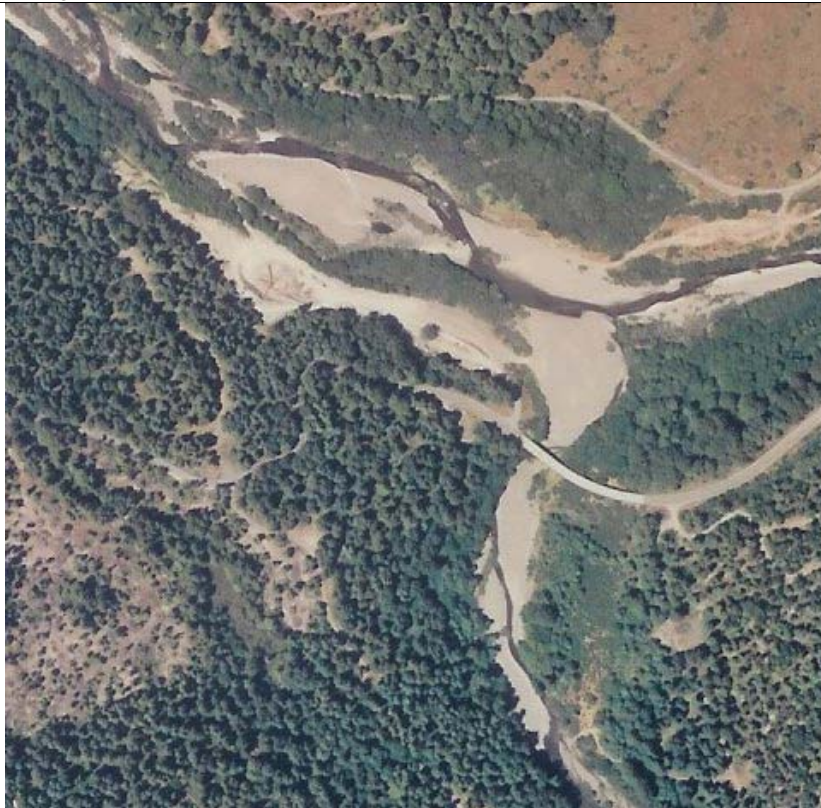
06/16/04      0 ' Up   Wheatfield      Dir 0      Cr Station 0      LWD Site      0  
12:00 PM   Photo 4020   Road# 40      Mi. 1.6      Map Pt. 2450   THP Maintenance  
The South Fork is on the right bank.
